# Inspection Report

12345 Any Home, North Alabama, AL 35613

**Inspection Date** November 18, 2018  
**Inspector** Kenneth Phillips  
kenneth.cdp@gmail.com

**CDP Home Inspections**

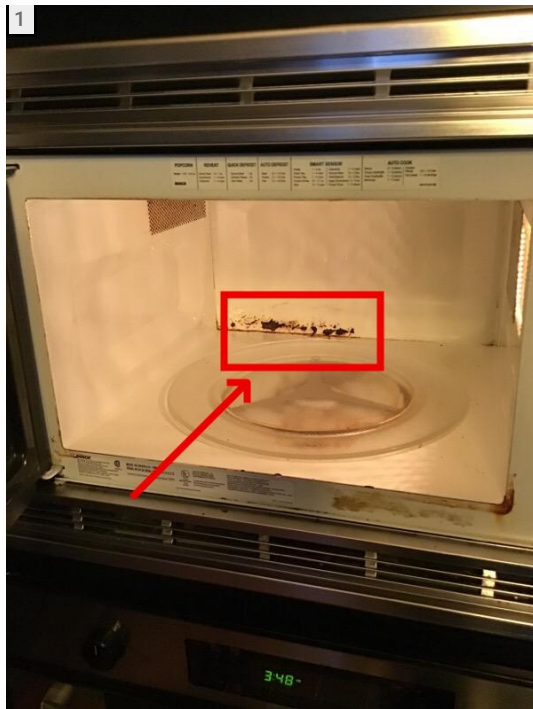
#### Interior shows cracking or other damage

**Location** Kitchen

**Impact** The cracks may allow the microwave to emit radiation beyond normal operation

**Suggested Action** Replace the unit

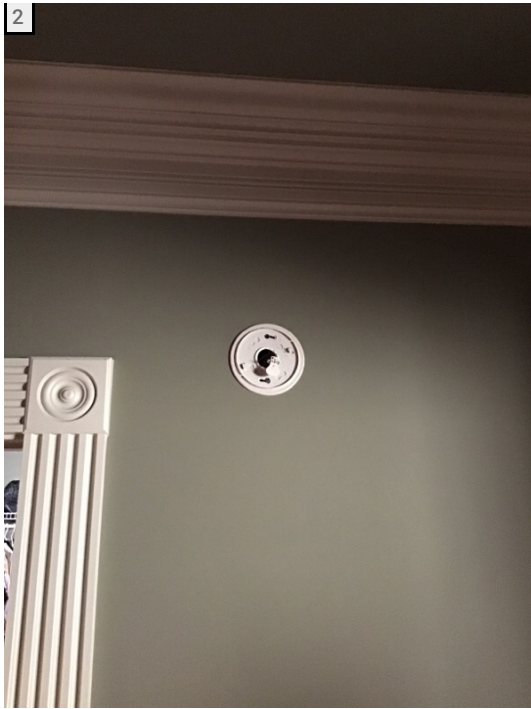
#### Missing

<b>Location</b>	1st Bedroom
<b>Impact</b>	Without one, high levels of carbon monoxide cannot be detected
<b>Suggested Action</b>	Install a carbon monoxide detector
<b>Other Information</b>	CO detectors should be located outside all sleeping areas and on every level of the home

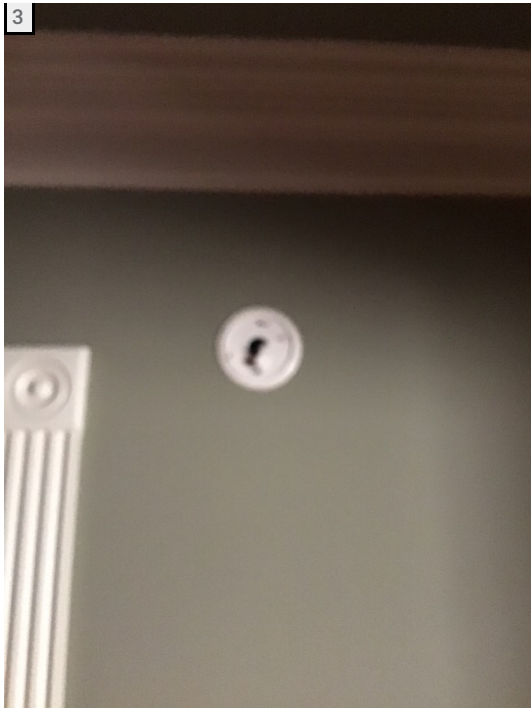
**Missing**

<b>Location</b>	1st Bedroom
<b>Impact</b>	Without one, smoke that may be an indicator of a fire can not be detected
<b>Suggested Action</b>	Install a smoke detector
<b>Other Information</b>	Smoke detectors should be located inside every sleep room, outside each sleeping area, and on every level of the home

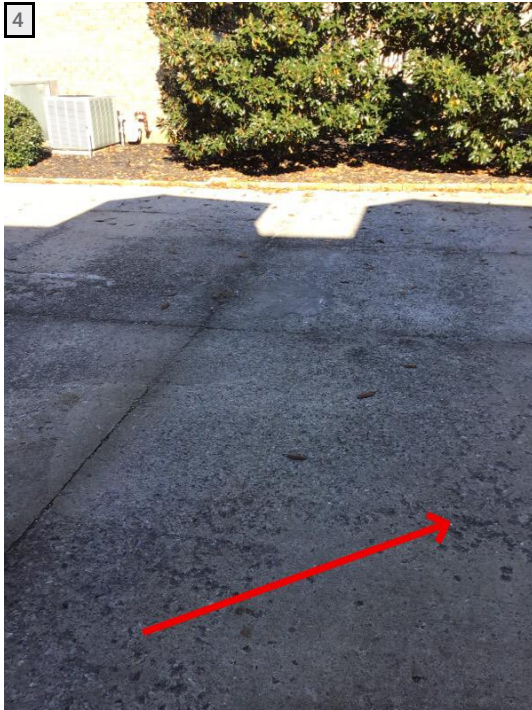
**Concrete is spalling**

**Location** Exterior: Ground View  
**Impact** If left unrepaired, spalls can accelerate pavement deterioration  
**Suggested Action** Repair either the damaged portion or entire driveway depending on your aesthetic preferences  
**Other Information** Spalling appears as circular or oval depressions on surfaces or as elongated cavities along joints

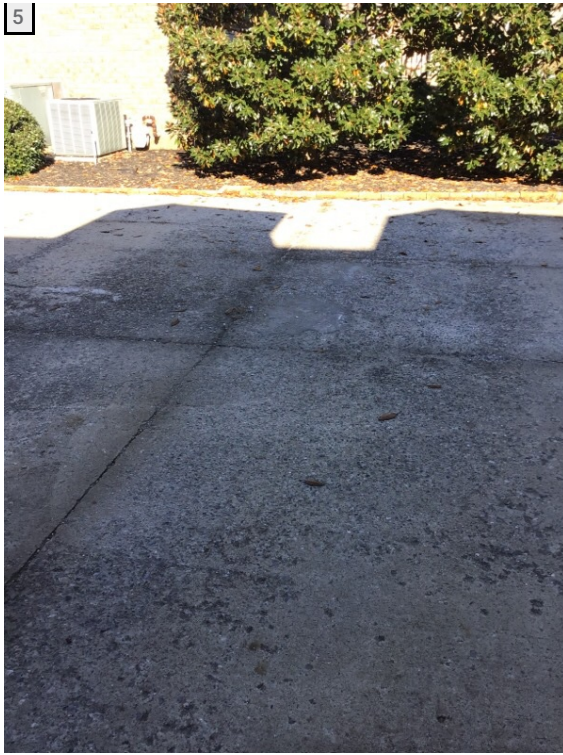
**Concrete pavement has low spots which are causing puddles / ponding**

**Location** Exterior: Ground View  
**Impact** Since the water in the low spots dries slower, the surface of the driveway will deteriorate faster  
**Suggested Action** Fill in the low spots with a concrete patching compound or remove the section of concrete at the low spot and pour new concrete

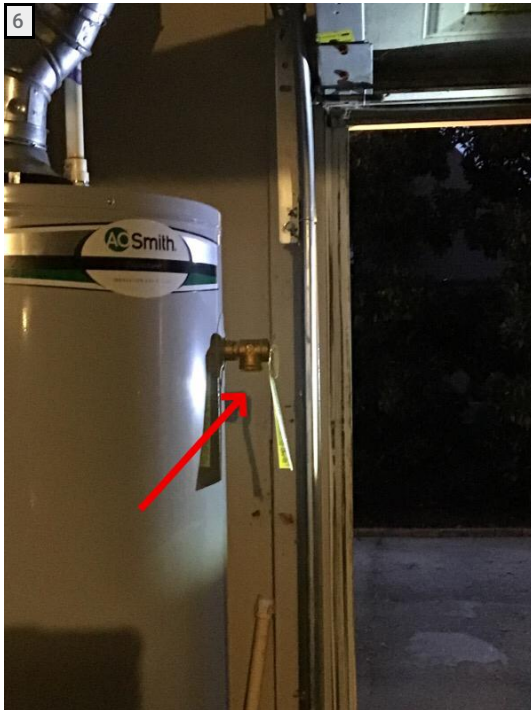
**TPR valve extension is missing or too short**

<b>Location</b>	Laundry Room / Mudroom
<b>Impact</b>	If the valve extension is higher than 6" from the floor and the valve trips, scalding hot water discharging could splash causing potential severe injury to those nearby
<b>Suggested Action</b>	Install a proper extension that terminates between 4 and 6" from the floor
<b>Other Information</b>	The relief valve should be piped to between 4 and 6" from the floor
